Technical Note N-832

CATHODIC PROTECTION OF MOORING BUOYS AND CHAIN

PART II. FURTHER FIELD STUDIES

by
Richard W. Drisko, Ph. D.

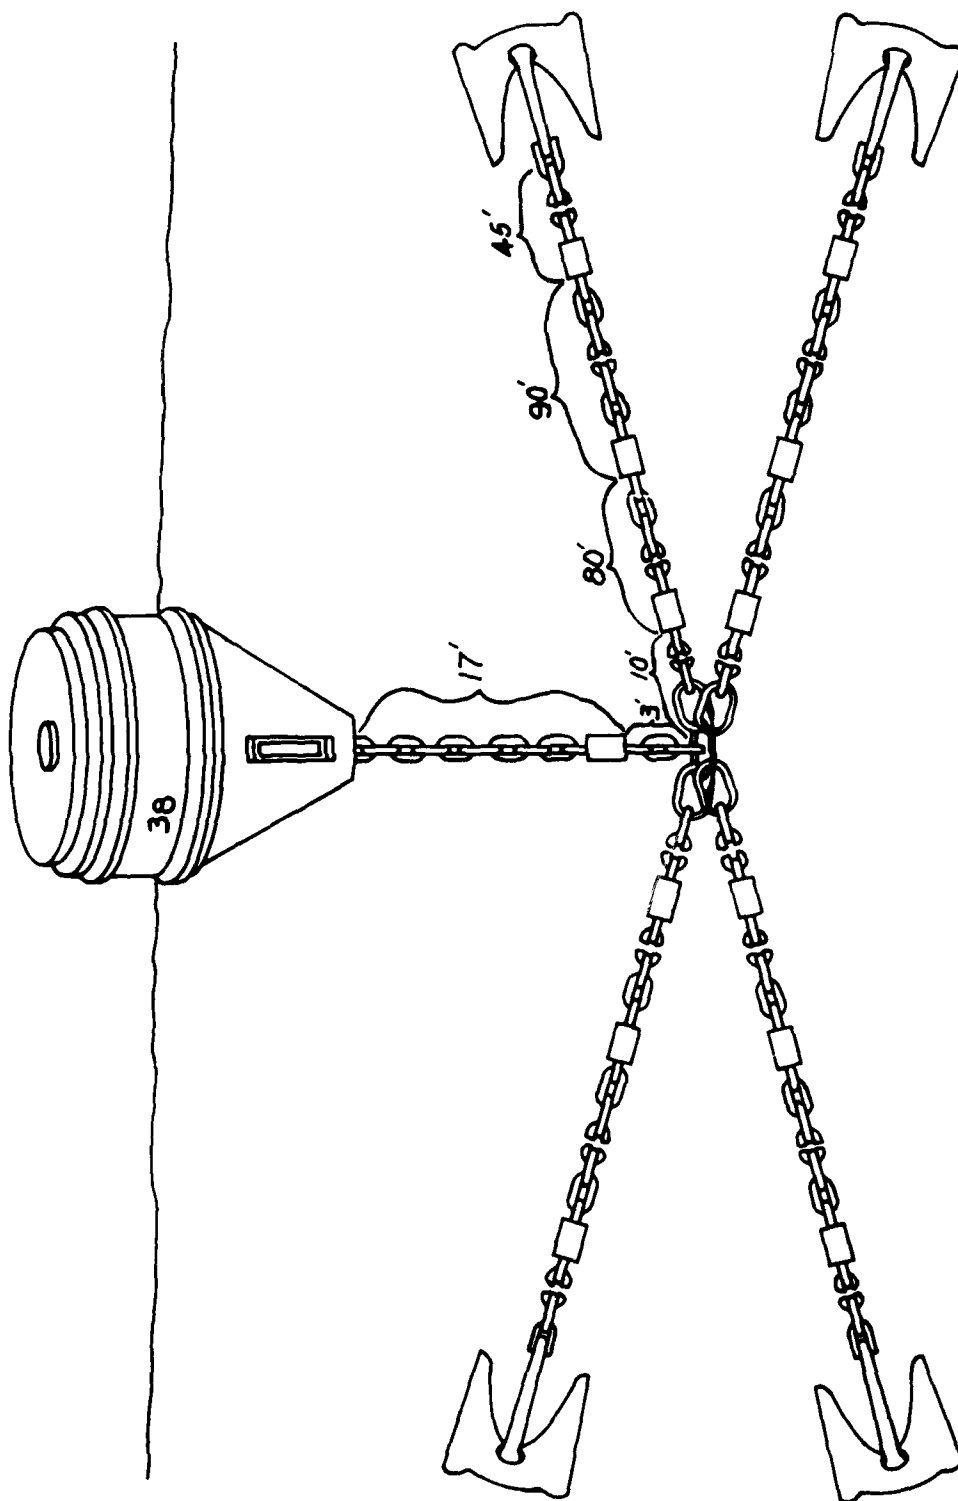
The design of the cathodic protection system is shown in Figure 2. Two of the smaller zinc anodes (approximately 144 lbs.) used in the previous study¹ were located in sea chests on opposite sides of the buoy cone. One of the special anodes was located on the riser-chain approximately three feet above the ground ring. Thus no place on the chain is further than 45 feet from an anode. The anodes were secured into the ground tackle using standard detachable links.

The specially prepared zinc anodes performed satisfactorily and showed no signs of passivation. They were present in sufficient quantity to provide complete protection to the mooring but lack of electrical continuity between chain links limited the amount of protection provided ground legs. Complete protection was provided to the underwater portion of the buoy and to the entire riser chain and the first twenty feet from the ground ring on each leg. These are the areas most corroded and the areas most costly in terms of both original purchase and maintenance. Thus the cathodic protection design in Figure 2, while not providing complete protection to

Figure 2. Cathodic Protection Design.

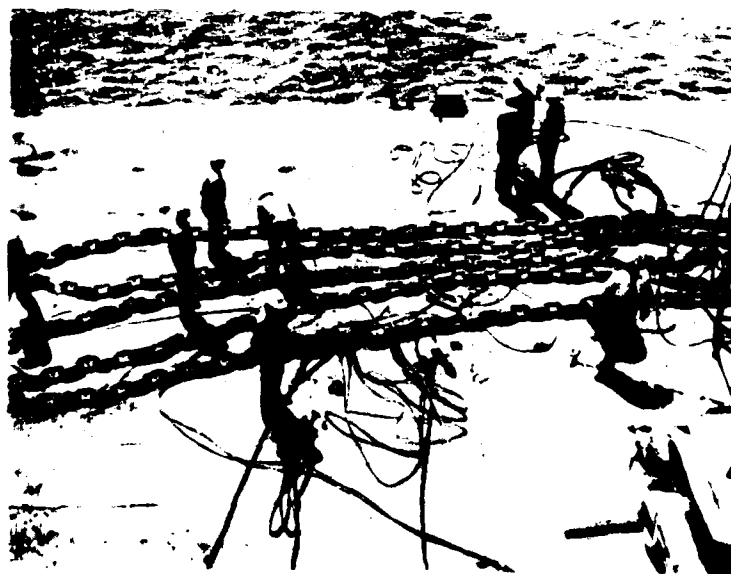
Figure 6. Ground leg on deck of floating crane showing cables threaded through it.

The ground legs on the test mooring were very tight. Frequent use of a mooring by ships tends to displace and slacken the ground legs. This would decrease electrical continuity and reduce the degree of cathodic protection. Thus use of wire cables threaded through the ground legs to provide the necessary continuity seems most desirable. The results in Table 3 indicate that Leg 4 is completely protected and the anchor is receiving nearly complete protection. Should this protection continue for a prolonged period of time, cables will be added to the other ground legs. Since the silver-soldering to chain links is time-consuming and may very slightly decrease their strength, consideration will be given to the use of screw-fitting connectors to join the cable to chain links.
